**Flood Control Project Maintenance
Levee Inspections**
LMA District Cover Sheet
Spring 2020 Levee Inspection Results

Lower San Joaquin Levee District

Spring 2020 Levee Inspection Results

Waterway			Bank	Unit Miles
Unit No. 01 San Joaquin River			Right	22.52
	Spring (March - May)	Summer (June - August)	(September - November) Fall	Winter (December - February)
Unit Maintenance Rating (Fall Only)				
Date of Inspection	4/21/2020 - 4/21/2020			
DWR Inspector	Corey Fujitani			
Accompanied By

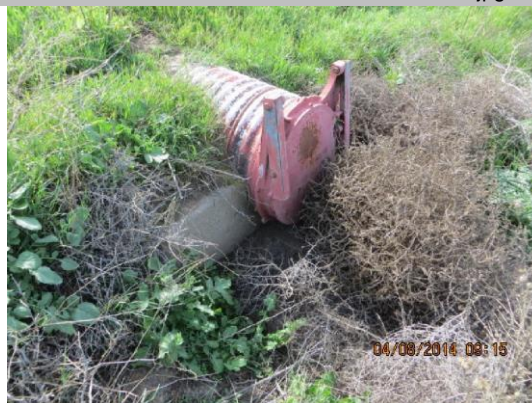
Photo 2 of 3 : UCIP_SP_2020_39095_60623.jpg

Flapgate and headwall visible on WS toe.

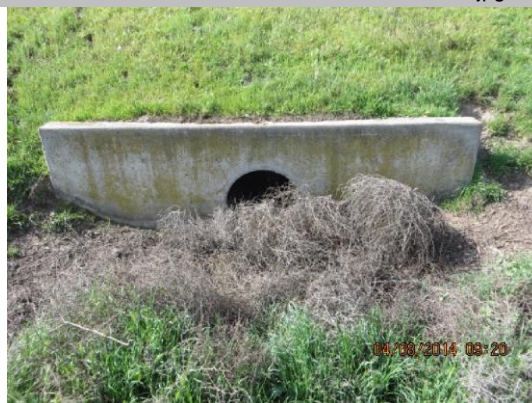
Photo 3 of 3 : UCIP_SP_2020_33524_60625.jpg

Pipe and headwall visible on LS toe.

Comment Code						
Inspector Comment						
DS_ID:19585 FS_ID:39096 EP_NO: N/A Repair Type: Non-Urgent Crossing Status: Found UCIP Comments: 04/08/2014 Moderate erosion around headwall on landward toe. May or may not be an issue. Need to contact owner to determine status of crossing and to address erosion issue on landward side. (DWR UCIP - W. Wylie) FIELD_STRUCT_DESC: 24-inch corrugated metal gravity drainage pipe through the levee, 7 feet below the crown. Flap gate on the waterside (WS) end. Brass cap No. 108 bench mark (BM) on the headwall on the landside (LS). [Additional Reference(s): DWR Levee Log, 2002. USACE San Joaquin O&M Manual 601.1, 1967, (HLM 0.95)]. FS Date: 4/8/2014

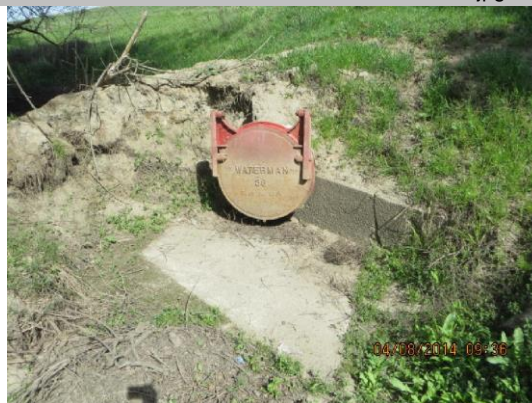
Photo 2 of 3 : UCIP_SP_2020_33544_60648.jpg

Concrete headwall and flapgate visible at WS toe.

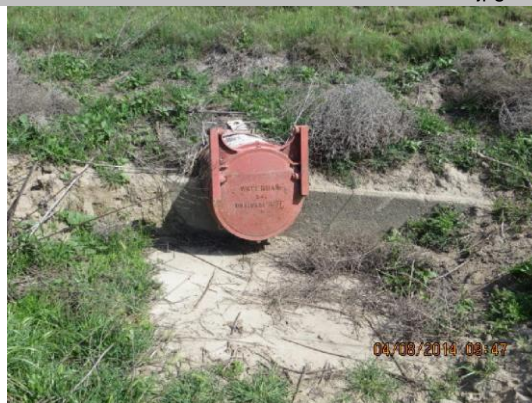
Photo 2 of 3 : UCIP_SP_2020_33563_60663.jpg

Pipe, headwall, and flapgate visible on WS toe.

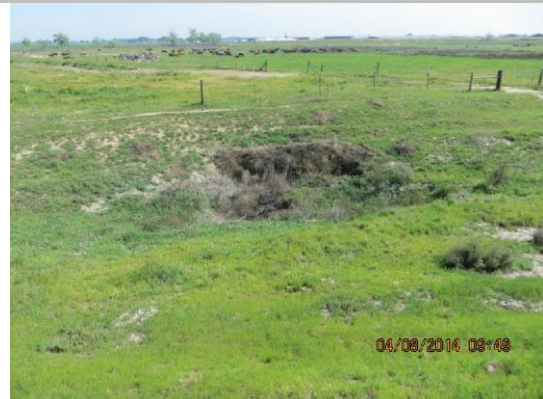
Photo 3 of 3 : UCIP_SP_2020_33564_60665.jpg

Pipe and concrete headwall visible at LS toe.

Comment Code						
Inspector Comment						
DS_ID:19591 FS_ID:39100 EP_NO: N/A Repair Type: Non-Urgent Crossing Status: Found UCIP Comments: 04/08/2014 Need to contact owner to determine crossing status. Inlet drop box silted in and needs to be cleaned out. (DWR UCIP - W. Wylie) FIELD_STRUCT_DESC: 24-inch corrugated metal gravity drainage pipe through the levee, 9.7 feet below the crown. Flap gate on the waterside (WS) end. Brass cap No. 100 bench mark (BM) on the headwall on the landside (LS). Wooden barrier around drop inlet on the LS toe. [Additional Reference(s): DWR Levee Log, 2002. USACE San Joaquin O&M Manual 601.1, 1967, (HLM 1.98)]. FS Date: 4/8/2014

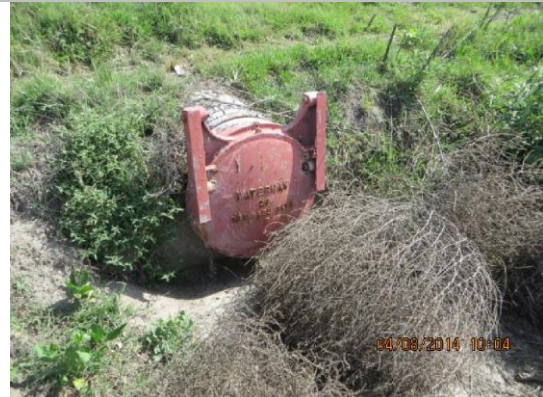
Photo 2 of 3 : UCIP_SP_2020_39123_60676.jpg

Pipe and flapgate visible on WS toe.

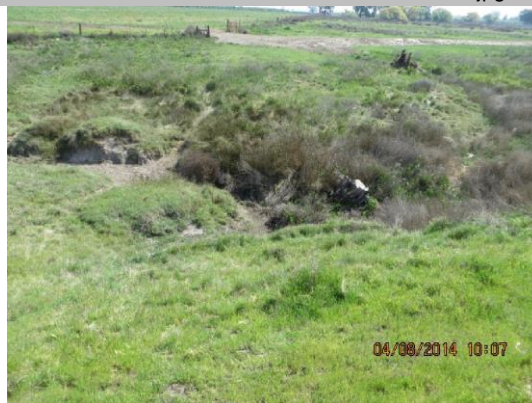
Photo 2 of 3 : UCIP_SP_2020_39125_71308.jpg

Pipe and headwall on LS toe.

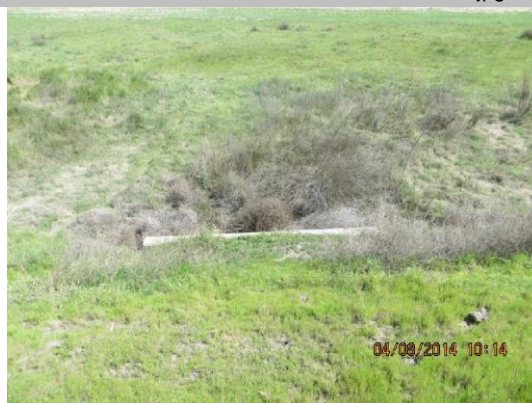
Photo 3 of 3 : UCIP_SP_2020_33568_60678.jpg

Pipe and headwall on LS toe.

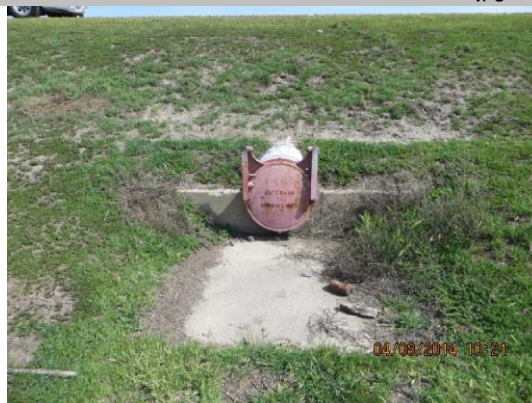
Photo 2 of 3 : UCIP_SP_2020_39127_60689.jpg

Pipe, flapgate, and headwall on WS toe.

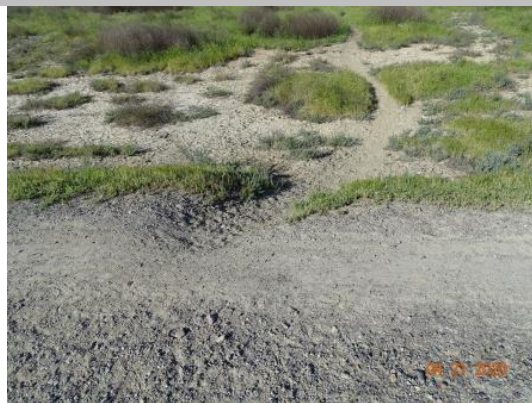
Photo 1 of 1 : SP_2020_NA0010_118_114_20200506_00292.jpg

LM Start	2.99	Rating **	M	Issue No.	114
LM End	2.99	Issue Type +	Ma	Location *	LS
Category	Earthen Levee			GPS Latitude/Longitude	
				Start	End
Item	Animal Control			37.323328 °	37.323328 °
				-120.929521 °	-120.929521 °
DWR ID	DWR_NA0010_01_f_2018_114				
Comment Code					
A2 : Repair the levee slope damaged by livestock and prevent large animal access.					
Inspector Comment					
Slope damage caused by livestock on both landside and waterside slope.

Slope damage from livestock activity. (Spring 2020)

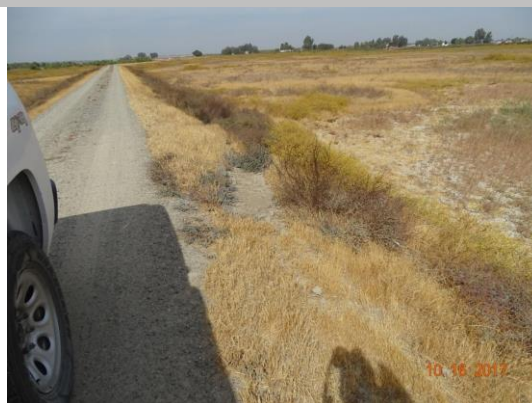
Photo 1 of 1 : SP_2020_NA0010_118_104_20200225_00018.jpg

LM Start	3.06	Rating **	A/W	Issue No.	104
LM End	3.06	Issue Type +	Ma	Location *	LS
Category	Earthen Levee			GPS Latitude/Longitude	
				Start	End
Item	Animal Control			37.322499 °	37.322499 °
				-120.928986 °	-120.928986 °
DWR ID	DWR_NA0010_01_f_2017_104				
Comment Code					
A2 : Repair the levee slope damaged by livestock and prevent large animal access.					
Inspector Comment					
Slope damage caused by foot traffic.

Looking northeast at the landside slope. (Fall 2017)

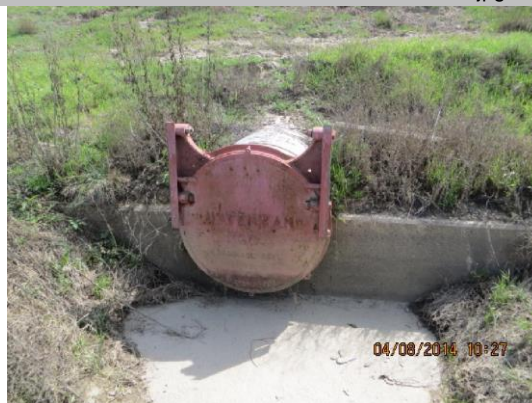
Photo 2 of 3 : UCIP_SP_2020_39128_60700.jpg

Pipe, Flapgate, and headwall on WS toe.

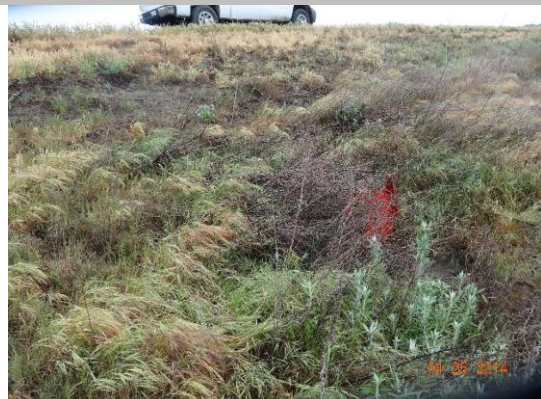
Photo 2 of 3 : UCIP_SP_2020_36169_65463.jpg

View of waterward slope covered by dense vegetation.

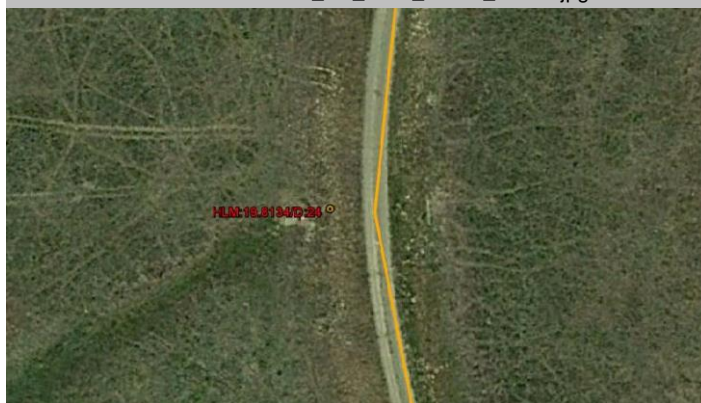
Photo 1 of 1 : UCIP_SP_2020_36253_65645.jpg

Indicators that a crossing is still present through the levee. Flap gate should be in waterward side.

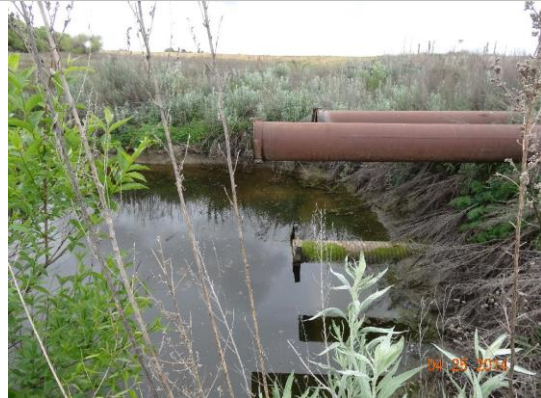
Photo 2 of 3 : UCIP_SP_2020_39878_66309.jpg

Multiple crossings visible on waterward side--36 inch CMP is submersed in water.

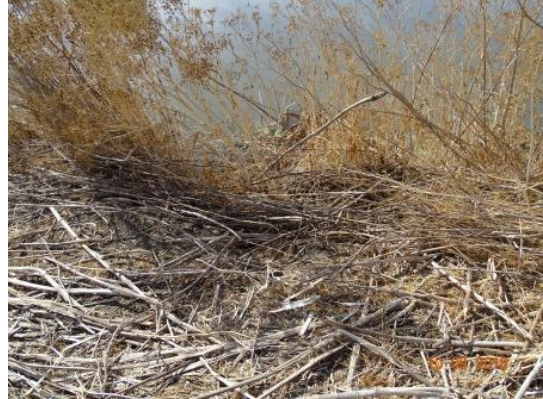
Photo 1 of 1 : SP_2020_NA0010_120_25_20200225_00014.jpg

Looking down landside slope from crown at erosion site. (Fall 2018)

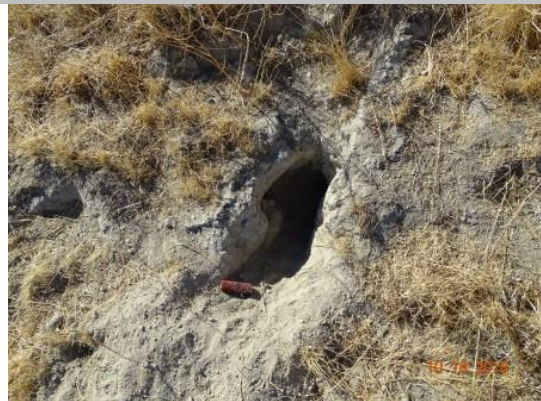
Photo 1 of 1 : SP_2020_NA0010_123_9_20200225_00008.jpg

View of representative rodent burrow. (Fall 2018)

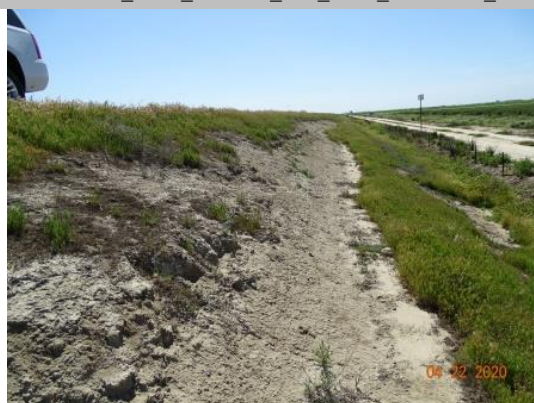
Photo 1 of 1 : SP_2020_NA0010_124_1209_20200508_00215.jpg

Erosion on the landside slope from livestock activity. (Spring 2020)

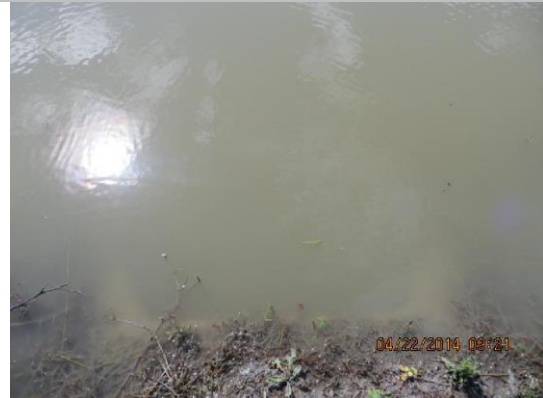
Photo 2 of 3 : UCIP_SP_2020_39888_62117.jpg

Concrete headwall visible under water on WS toe.

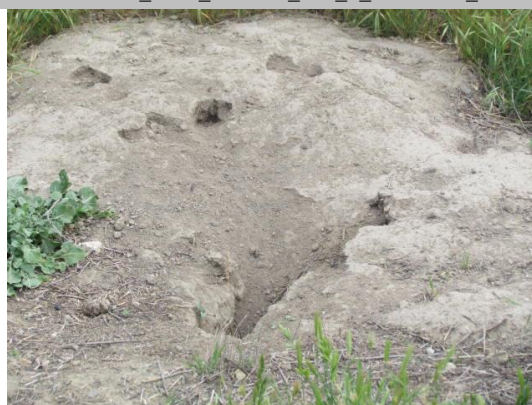
Photo 1 of 1 : SP_2020_NA0010_135_8_20200225_00006.jpg

Looking at several rodent holes on landside slope. (Fall 2014)

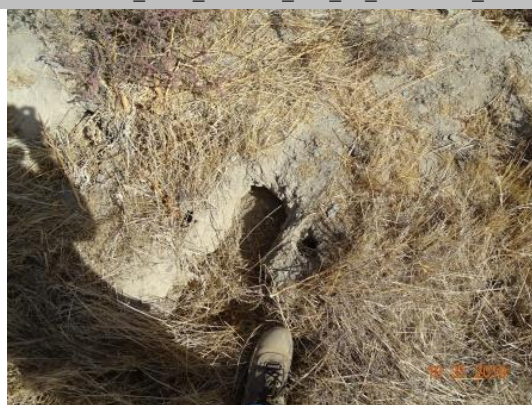
Photo 1 of 1 : SP_2020_NA0010_137_23_20200225_00012.jpg

Representative view of rodent burrows observed at this location. (Fall 2019)

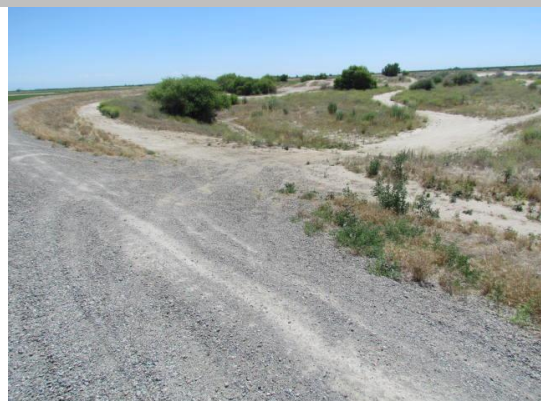
Photo 1 of 1 : SP_2020_NA0010_139_16_20200225_00004.jpg

Looking west at one of several damaged slopes cause by vehicle traffic.

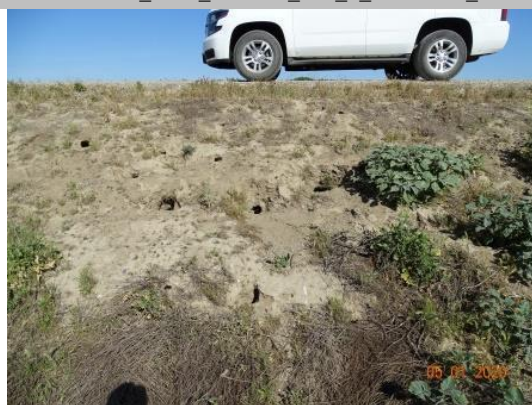
Photo 1 of 1 : SP_2020_NA0010_140_6_20200514_00034.jpg

Rodent burrows in the landside slope. (Spring 2020)

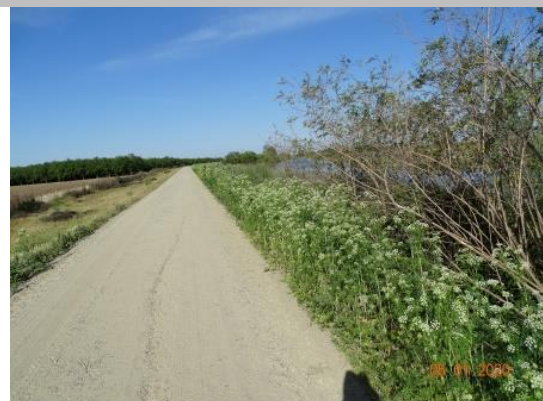
Photo 1 of 1 : SP_2020_NA0010_140_33_20200514_00035.jpg

View of vegetation on the waterside slope looking downstream. (Spring 2020)
